# Manhole Inspection Summary

Manhole # S55M\_\_018MH

Insp Date: **6/6/08 9:36 AM**

**Location** Address: **1000 baylis st**

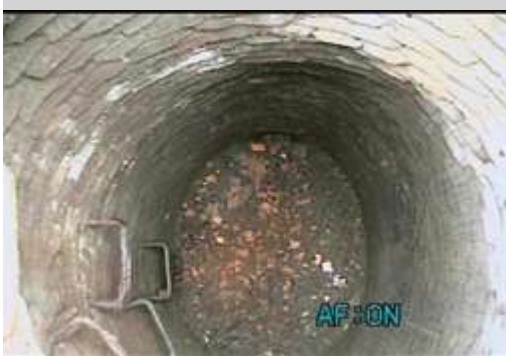
Defect 3

Condition: ☐ Sound ☐ Cracked ☐ Root Intrusion ☐ Deteriorated ☐ Leaks ☒ **Debris**

channel debris

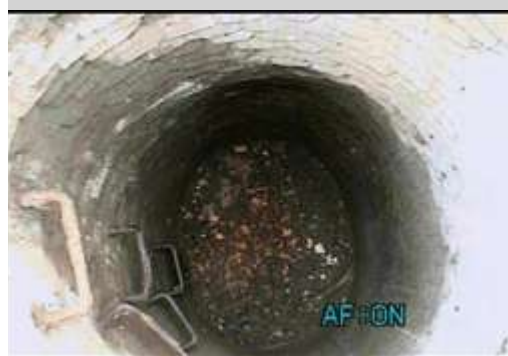
Defect 2

Count: **5** Missing: **0** ☒ **Corroded**

corroded steps

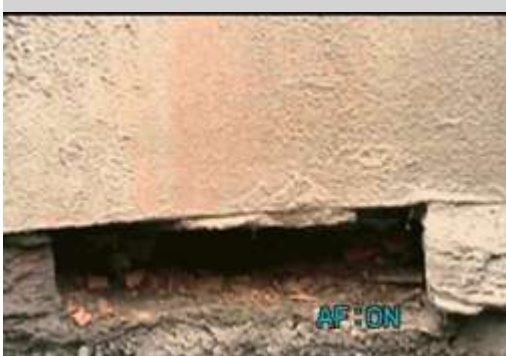
Defect 1

Condition: ☐ Sound ☐ Cracked ☐ Root Intrusion ☒ **Loose Brick** ☐ Deteriorated

loose bricks in chimney
